# CASE STUDY

98 metre skirt damage conveyor belt repair.

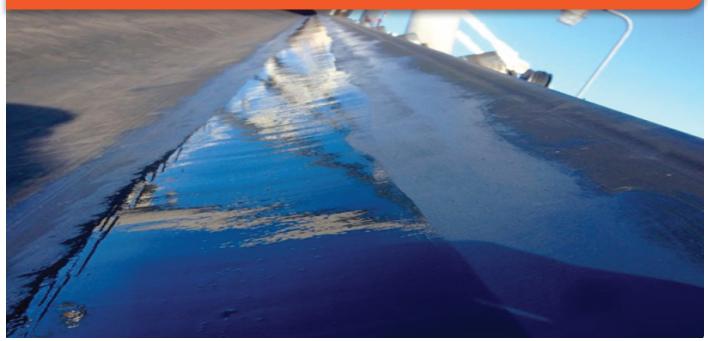
The re-claimer elevator conveyor belt had a damaged section that ran along the entire 96-metre length of belt with exposed cables. The repair was required because the hard skirt had worn away a 150mm (W) x 10mm (D) groove into the belt.

CoBond Qik Fix (30 minute cure time).

Additionally the conveyor was not required to be removed from service for 3 days to allow the belt to be replaced. The repairs were performed in planned maintenance windows delivering the client increased availability and throughput.

The above repair remained in service, without issue, until the belt was dur for replacement.
