Conveyor Belt Repair

Repair: Complex edge repair with exposed steel cable

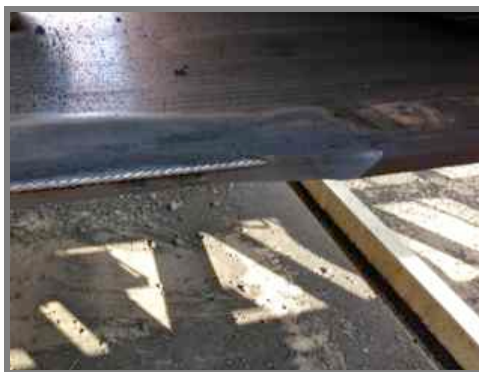
A material loading facility required an edge repair to be completed to a damaged conveyor belt that had been cut away and had left the steel cable exposed. The repair was 10 metres in length and required the edge to be built out 20mm and encase the steel cable.

Above - damage to the edge exposing cable

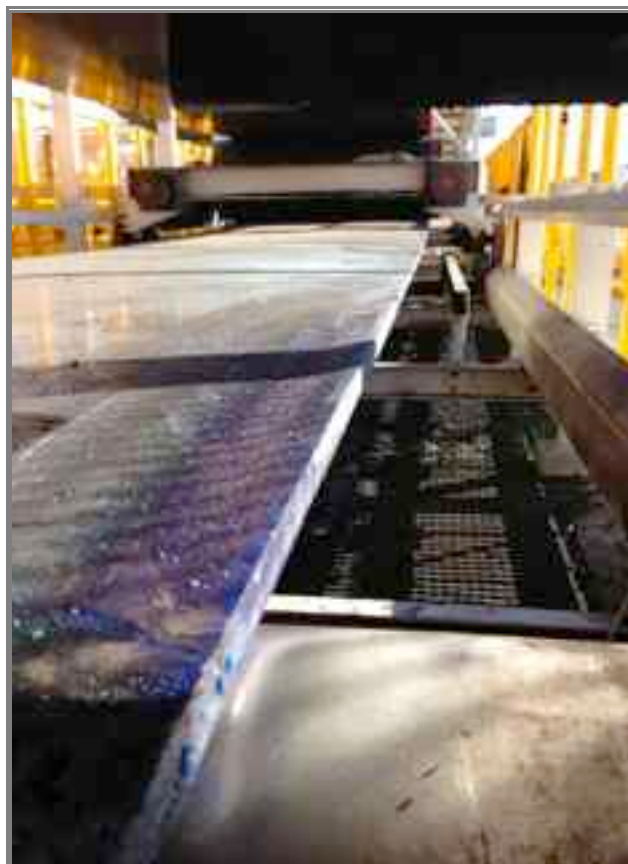
Right – repair completed

We were able to fully repair the belt by building out the edge across the 10-metre section and encasing the steel cable into the repair.
