Conveyor Belt Repair

Repair: Edge damage – fabric belt

Material: Qik Fix Conveyor Repair

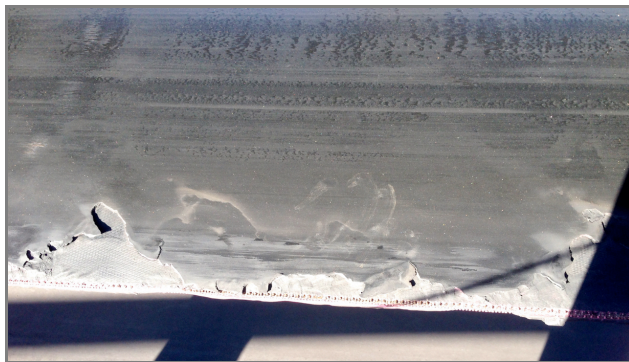
A power station required an edge of the conveyor belt to be rebuilt after only having installed the belt for 6 months. The repair was 60 metres in length and required the edge to be rebuilt as a result to alleviate the 'shark bite' effect.

The edge damage to the fabric belt

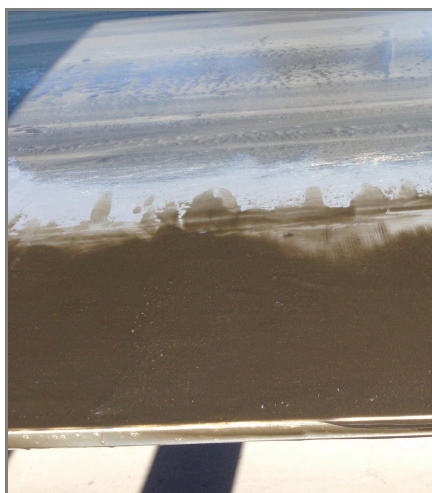
The edge has been rebuilt

We were able to fully rebuild the edge and encase and protect the fabric from moisture.
