## Conveyor Belt Repair

**Repair:** 120-metre skirt damage conveyor belt repair

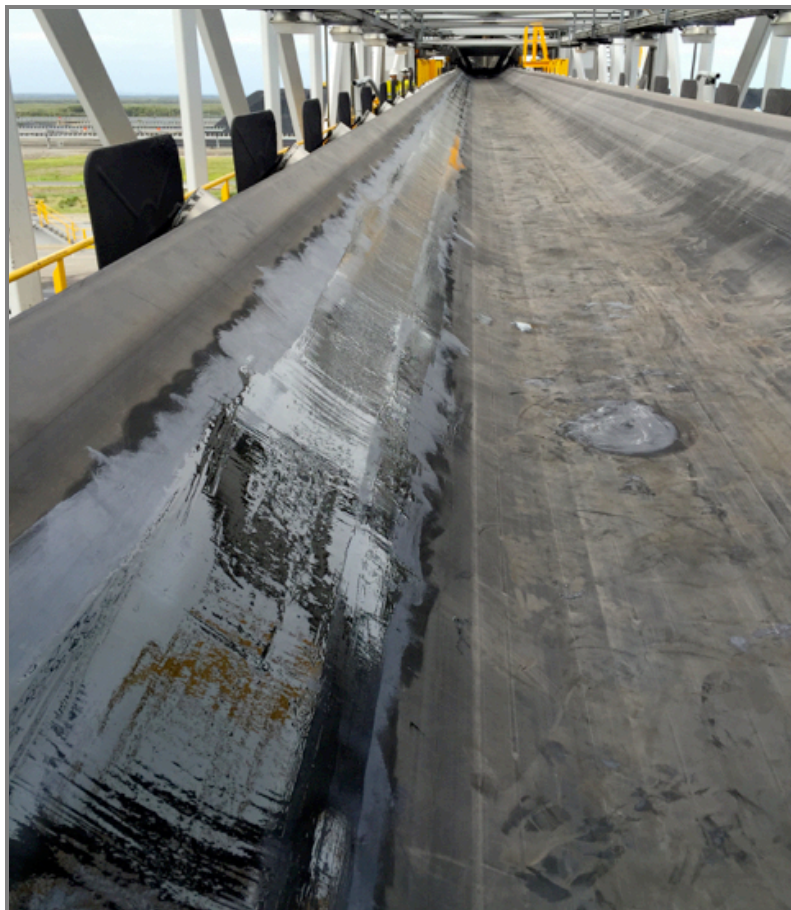
The re-claimer boom conveyor belt had a damaged section that ran along the entire 120-metre length of the belt. The repair was required because a large rock was caught between the skirt and the conveyor belt and had worn away a 100mm (W) x 12mm (D) deep groove in the belt.

**Material:** Qik Fix (30 minute cure time)

Rather than changing out the belt at considerable cost, the belt was repaired at a fraction of the replacement cost – see image below.

There have been no issues with the repairs following the belt returning to full service.
