Conveyor Belt Edge Repair

Repair: 96-metre skirt damage conveyor belt repair

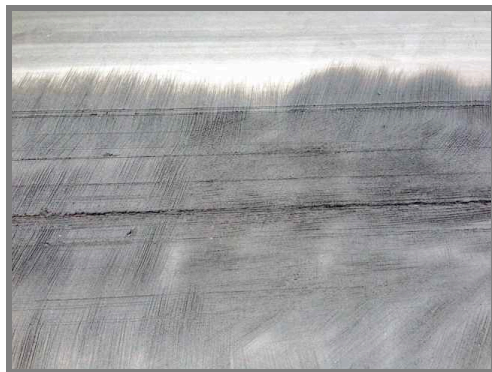
The conveyor belt had a worn out section that ran along the entire 96-metre length of the belt. The repair was required as a result of the hard skirt wearing away a 100mm (W) x 15mm (D) groove into the belt.

Damage to the belt from the skirt.

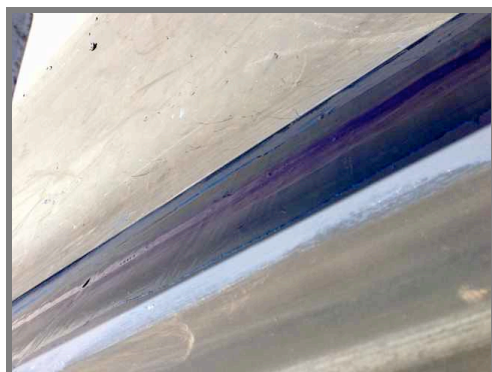
Repair completed.

Material: Rapid Repair (2 hour cure time)

This repair required three stages to complete. At the end of each stage, the belt was available for use at the completion of the shutdown.
