CASE STUDY

120m skirt damage conveyor belt repair.

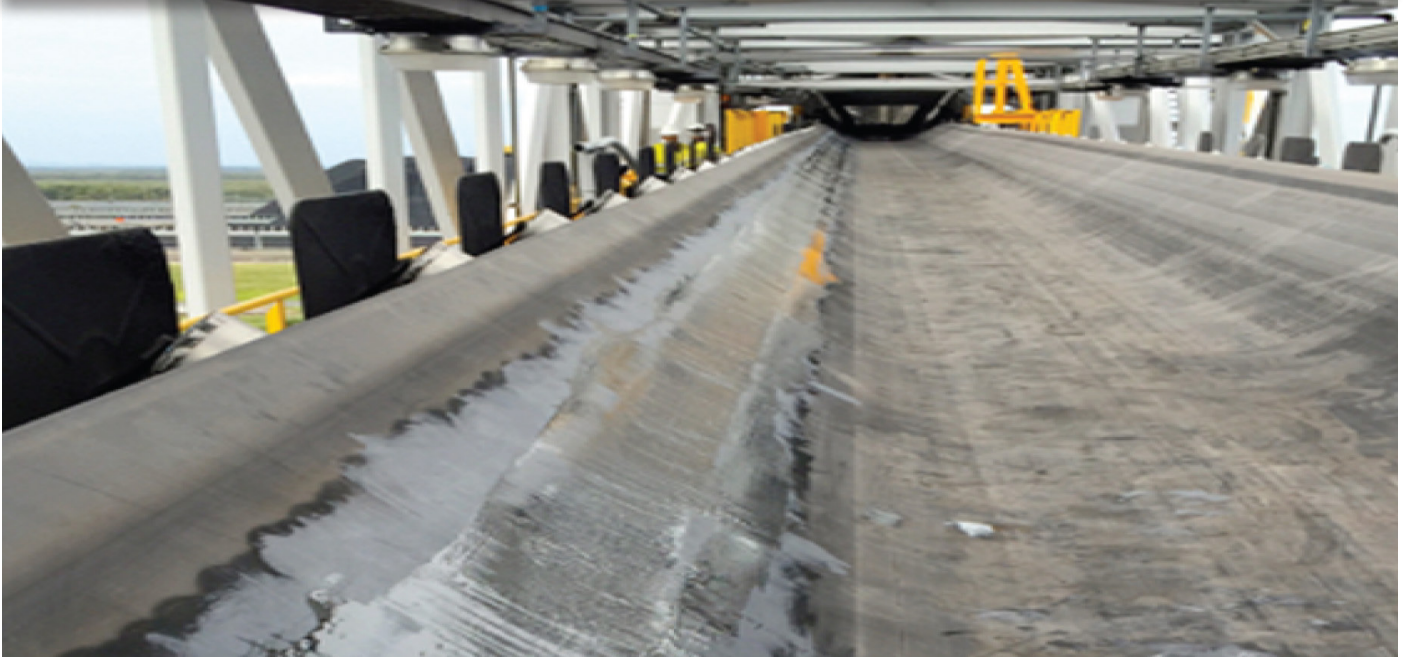
The re-claimer boom conveyor belt had a damaged section that ran along the entire 120-metre length of belt. The repair was required because a large rock was caught between the skirt and the conveyor belt and had worn away a 100mm (W) x 12mm (D) deep groove in the belt.

CoBond Qik Fix (30 minute cure time).

Additionally the conveyor was not required to be removed from service for 3 days to allow the belt to be replaced. The repairs were performed in planned maintenance windows delivering the client increased availability and throughput.

The above repair remained in service, without issue, until the belt was due for replacement.
