Ceramic Wear Plate Liners

Project: Ceramic Wear Plate Liners – Centrifuge Chutes

Material: Coal – 8,000 tonnes per hour

Location: Hunter Valley, New South Wales

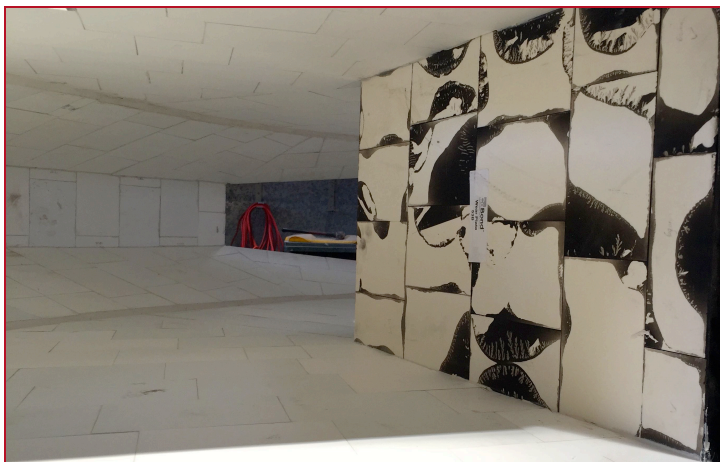
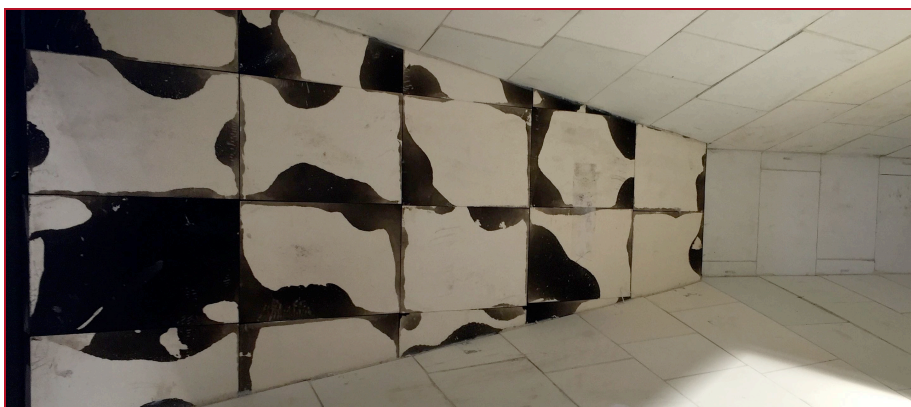
Our customer required a solution that would solve the issue of tiles cracking and breaking up and falling out in the high impact areas of their centrifuge chutes.

Our ceramic wear liners comprise of advanced ceramic tiles, bonded in a high tensile strength polymer matrix to a studded steel backing plate.

These wear liners were bonded using our proprietary bonding process that enables an engineering grade bond between the ceramic and the steel plate to be achieved.

As a result the bonded ceramics have provided superior impact and wear resistance.
