Conveyor Belt Repair

Repair: **Reseal edge – fabric belt**

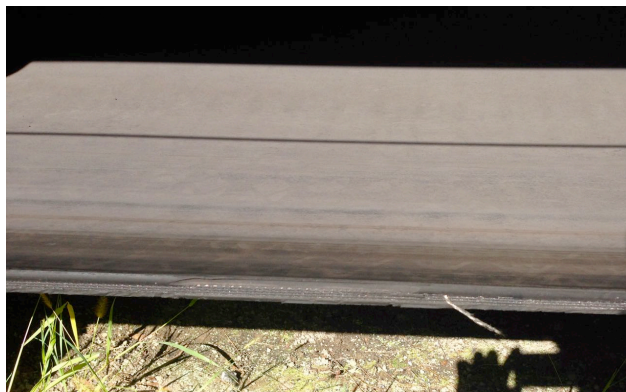
Our customer required the edge of the conveyor belt to be resealed because the 2mm protective rubber edge had been removed from the edge of the conveyor belt.

The edge damage to the fabric belt

The repair was required so as to prevent moisture from penetrating the fabric and delaminating the rubber. This repair was 700 metres in length and required the exposed fabric to be resealed.

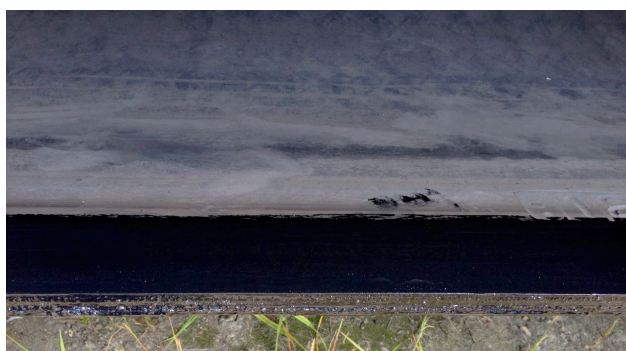
The edge has been resealed

We were able to reseal the entire edge and protect the fabric from moisture. The repair was completed saving time and considerable cost and the belt was available for use at the completion of the shut down. There have been no issues with the repairs following the belt returning to full service.
