## Conveyor Belt Repair

**Repair:** Spot / Puncture Repairs

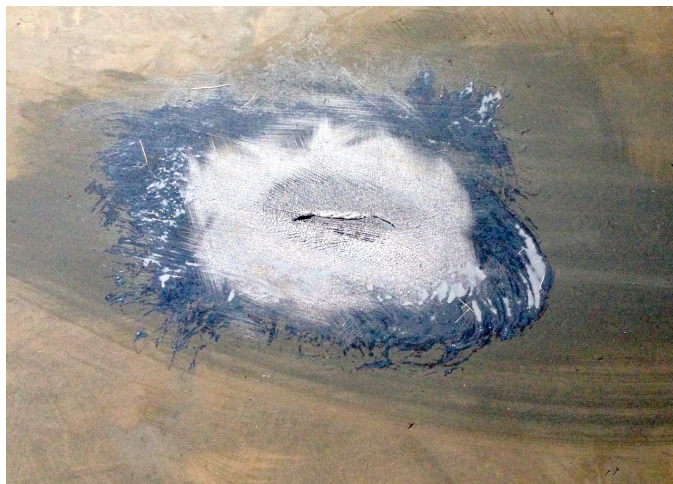
A material loading facility required had 40 spot repairs to the boom conveyor as a result of material being caught in between the pulley and the conveyor belt.

An example of the spot repair (primed)

**Material:** Rapid Repair (2 hour cure time)

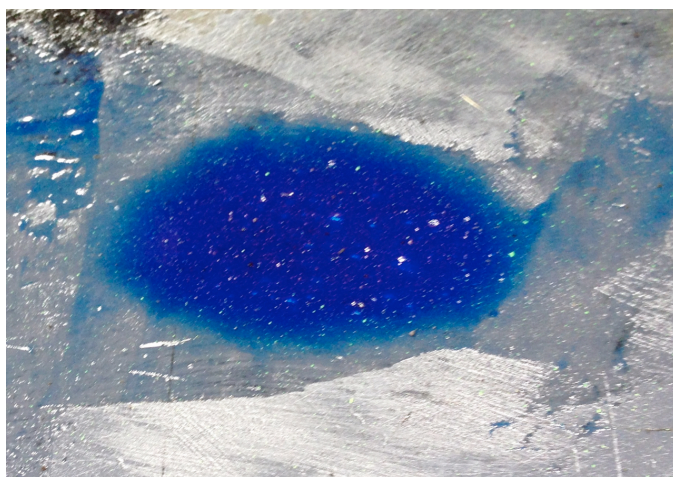
Repair completed

The repair was completed saving time and considerable cost and the belt was available for use at the completion of the shut down. There have been no issues with the repairs following the belt returning to full service.
