Conveyor Belt Repair

Repair: 14-metre edge damage to conveyor belt repair

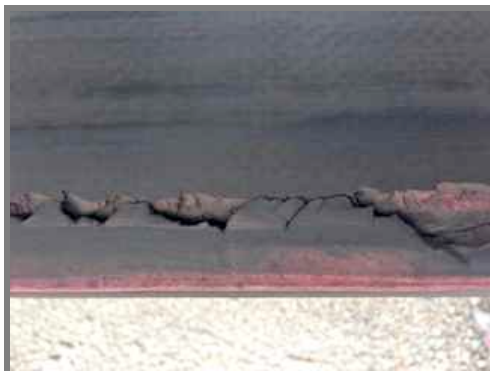
The conveyor belt had drifted causing considerable damage to the edge of the belt. The repair was required so as to avoid the edge tearing away and potential ripping out the cable.

Edge to be repaired

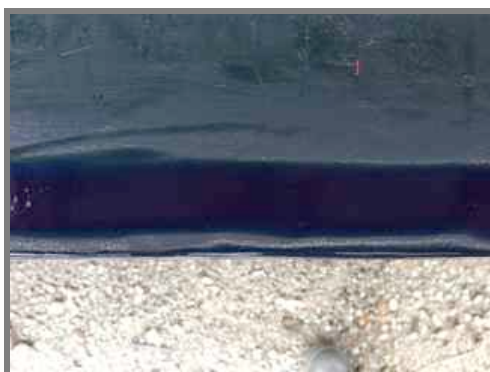
Edge repaired

Rather than risk the edge tearing away and ripping out the cable and then having to replace the entire belt - \$500K, we undertook to repair the edge to build strength back into it and thus protecting the cable.

There have been no issues with the repairs following the belt returning to full service.
