Polyurethane Coating

Application: Conveyor pulley

Material: Polyurethane protective coating (CoBond Protect)

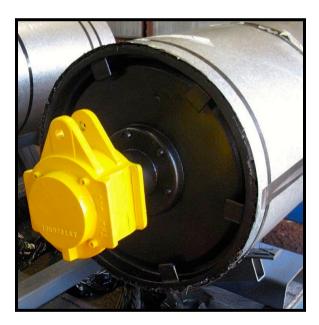
Our customer required a new solution that would greatly reduce the corrosion of the ends of their conveyor pulleys. Their pulleys where exposed to severe environmental (salt water) factors which eroded the ends of the pulleys.

We developed a specific polyurethane coating that can be sprayed onto the pulley and therefore protecting the ends of the pulley from the harsh environmental conditions. This coating assists in reducing the effects of corrosion on the pulley that in turn has increased the life span of the component.
