**CoBond™**  
MATERIAL SOLUTIONS

**Conveyor Belt Repairs**

# Faster, Stronger, Cheaper Repairs

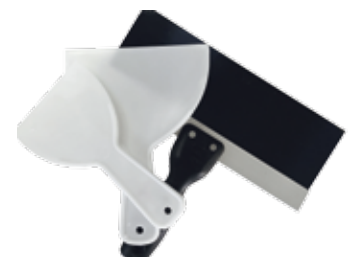
### Applicators

CoBond's range of scraper blades are ideal for applying CoBond's Conveyor Belt Repair Kit to achieve a smooth and even finish to a repair.

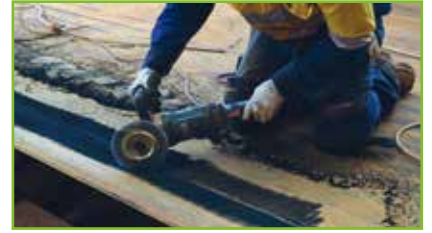
### Step 1

**Prepare surface** – clean and grind out the repair area with a wire brush/wheel. Ensure a profile in the rubber is produced.

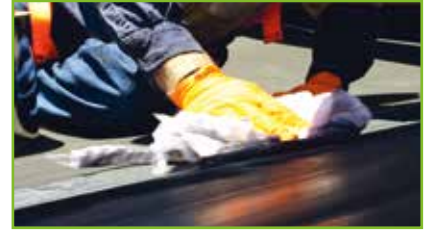
### Step 2

**Clean the surface** – use Acetone, Perchloroethylene (PERT) or MEK solution with a clean plain white rag to thoroughly clean the surface.

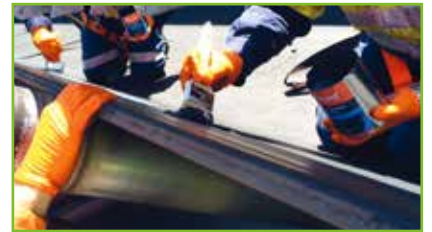
### Step 3

**Prime the surface** – thoroughly mix and brush on 2 separate coats of CoBond Primer No.6 – allow 20 – 45 minutes drying time on the 1st coat and then apply a second coat.

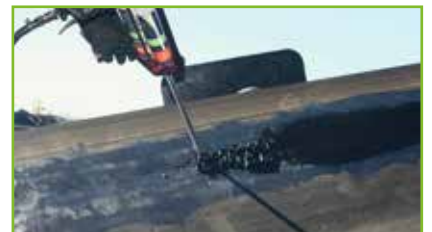
### Step 4

**Repair the surface** – once the second coat of the Primer No.6 is tacky, fill the repair area using CoBond's conveyor repair kit.

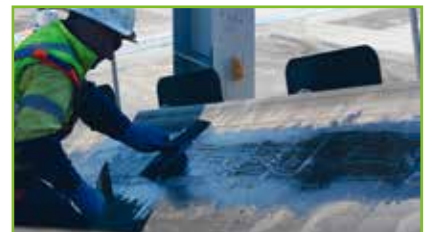
### Step 5

**Finish the surface** – use a scraper blade to smooth out the material to the repair area and feather out the edges (no need to buff once completed).

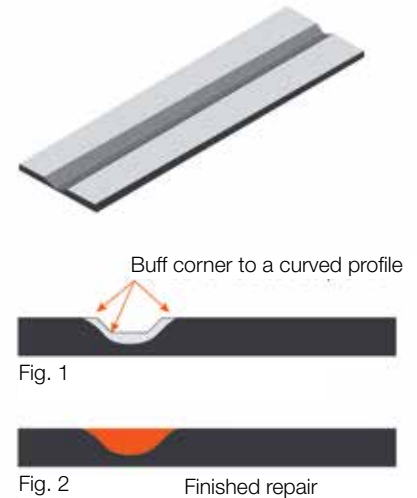
### Skirt-line Damage Repair

**Step 1 – Prepare Surface** – clean and buff the repair area with a wire brush/wheel. Ensure a profile in the rubber is produced and a rounded profile with no sharp edges or corners as per figure 1.

**Step 5 – Finish the repair** – use a scraper blade to smooth out the material to the repair area (as per figure 2) and feather out the edges (there is no need to buff the repair once completed).

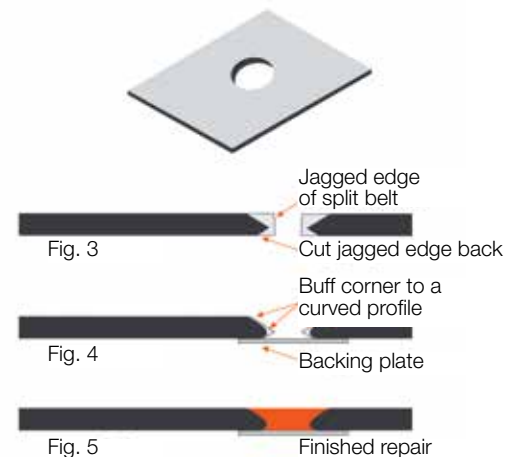
### Puncture or Hole Repair

**Step 1** – Cut the top and bottom jagged edge of the puncture or hole with a knife as per figure 3.

**Step 2 – Prepare Surface** - clean and buff the repair area with a wire brush/wheel. Ensure a profile in the rubber is produced and a rounded profile with no sharp edges or corners as per figure 4.

**Step 5** – apply and secure backing or base plate of melamine, aluminum under repair as per figure 4.

**Step 7 – Finish the repair** – use a scraper blade to smooth out the material to the repair area (as per figure 5) and feather out the edges (there is no need to buff the repair once completed). Once cured, remove the backing plate.

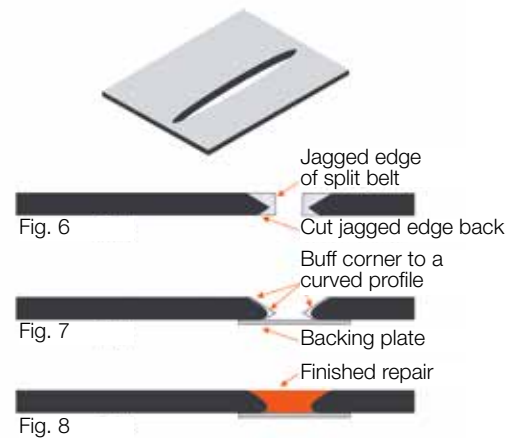
### Split Repair

**Step 1** – Cut the top and bottom jagged edge of split with a knife as per figure 6.

**Step 2 – Prepare Surface** – clean and buff the repair area with a wire brush/wheel. Ensure a profile in the rubber is produced and a rounded profile with no sharp edges or corners as per figure 7.

**Step 5** – apply and secure backing or base plate of melamine, aluminum under repair as per figure 7.

**Step 7 – Finish the repair** – use a scraper blade to smooth out the material to the repair area (as per figure 8) and feather out the edges (there is no need to buff the repair once completed). Once cured, remove the backing plate.

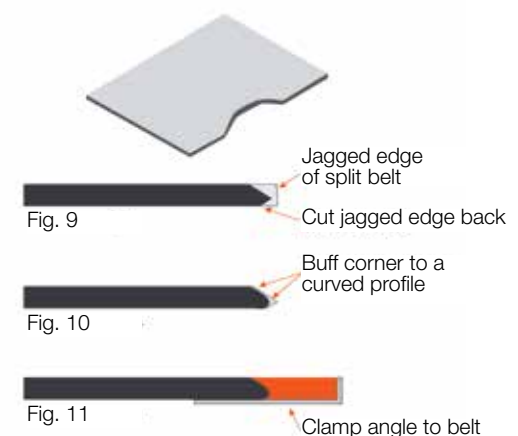
### Edge Repair

**Step 1** – Cut the top and bottom jagged edge of the belt with a knife as per figure 9.

**Step 2 – Prepare Surface** - clean and buff the repair area with a wire brush/wheel. Ensure a profile in the rubber is produced and a rounded profile with no sharp edges or corners as per figure 10.

**Step 5** – apply and secure the aluminum mould under repair as per figure 11.

**Step 7 – Finish the repair** – use a scraper blade to smooth out the material to the repair area (as per figure 11) and feather out the edges (there is no need to buff the repair once completed). Once cured, remove the mould.

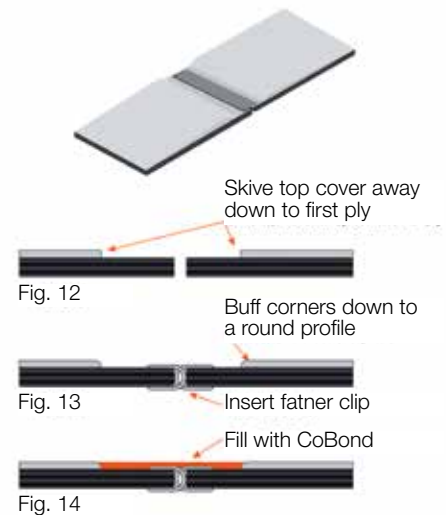
## Mechanical Fastener Protection

**Step 6 – Finish the repair** – use a scraper blade to smooth out the material to the repair area (as per figure 14) and feather out the edges (there is no need to buff the repair once completed).

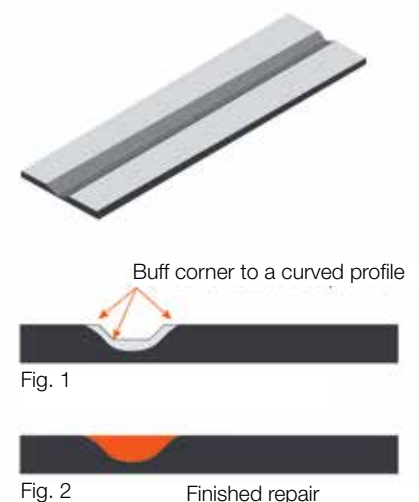
## Skirt-line Damage Repair

**Step 1 – Prepare Surface** – clean and buff the repair area with a wire brush/wheel. Ensure a profile in the rubber is produced and a rounded profile with no sharp edges or corners as per figure 1.

**Step 5 – Finish the repair** – use a scraper blade to smooth out the material to the repair area (as per figure 2) and feather out the edges (there is no need to buff the repair once completed).

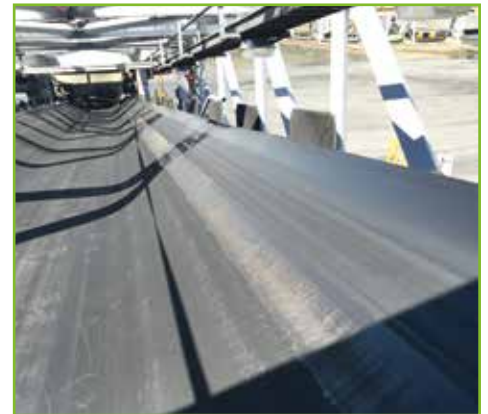
**REPAIR:** 146 metre skirt-line damage conveyor belt repair

Importantly, the repairs were performed during planned maintenance windows, allowing the belt to remain in service without any issues for a further 16 months until the normal replacement date.

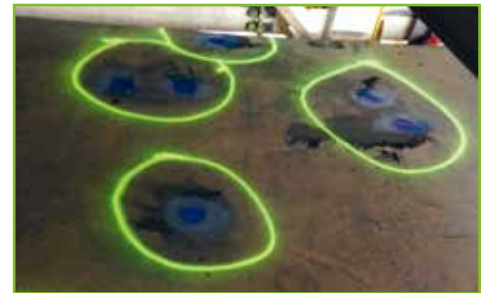
**REPAIR:** Spot / puncture repair

**PRODUCT:** CoBond Rapid Repair / Primer No.6

The repairs were performed during a planned maintenance window, allowing the belt to remain in service without any issues.

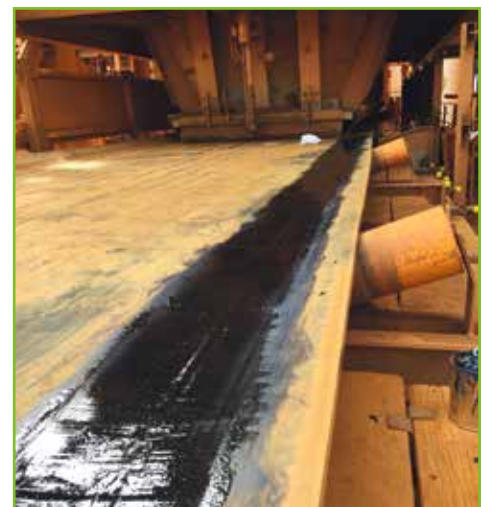
**REPAIR:** 60 metre skirt-line damage conveyor belt repair

**PRODUCT:** CoBond Qik Fix / Primer No.6 / Primer No.3

Importantly, the repairs were performed during a planned maintenance window. The repair enabled the belt to remain in service for a further 12 months.
