## Conveyor Belt Repair

**Repair:** Splice damage conveyor belt repair

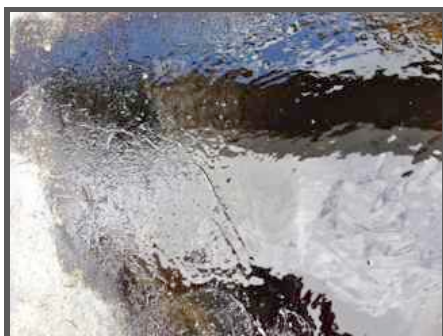
Repair completed.
